Santa Fe River Study

Report on Existing Environmental Conditions
and
Potential Natural Resources
Restoration Projects

5 December 2007

Prepared for
U.S. Army Corps of Engineers, Albuquerque District
Delivery Order 0014, Contract No. DACW47-03-D-005

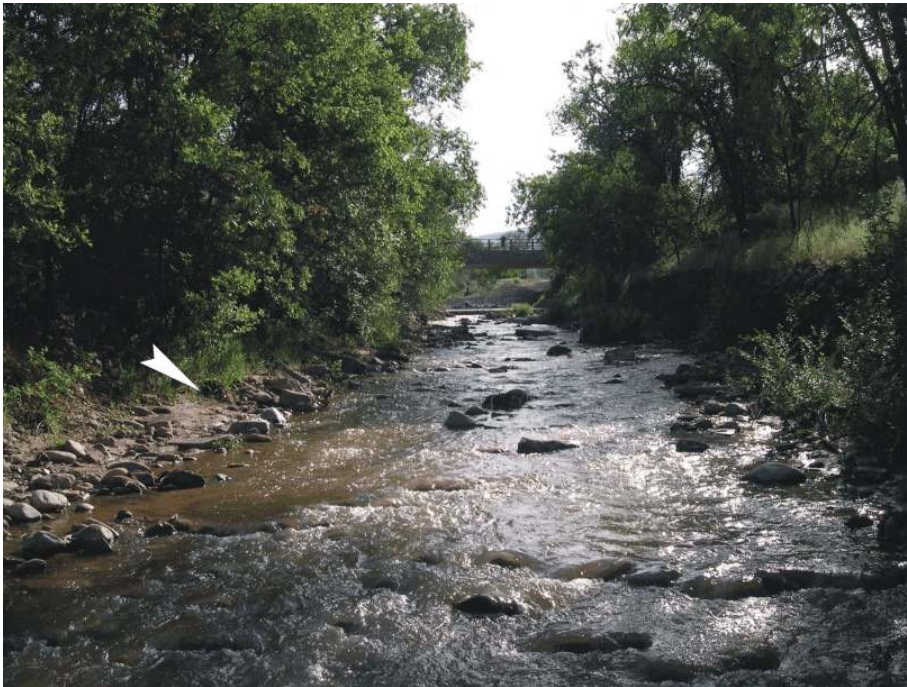
The B stream type is moderately entrenched with moderate bankfull width-to-depth ration and a relatively steep gradient (2 to 4 percent). The B-type channel in the study area has a bed dominated by gravel with some sand and cobbles. In the study area, the B4 stream segment is bounded on the downstream end by a grade control structure. This stream type was delineated in segment SFR-1, which is a 1,767-foot reach downstream from Camino Alire (Figure 11). Gabion basket walls line portions of the banks in this reach. Degradation is not occurring in the B-type channel segment in the study area. Furthermore, rapid channel widening is not occurring, as evidenced by vegetated banks and absence of raw, vertical cuts (Figure 12). Therefore, following the preceding discussion in

section 2.4.2.1, the probable channel evolution stage of segment SFR-1 is IV or V, which is nearing equilibrium condition.

Figure 12. Stream type B4 below Camino Alire bridge. Arrow indicates field determination of bankfull stage. View is upstream, with the bridge in the background. Photo by J. Pittenger, 28 May 2007.

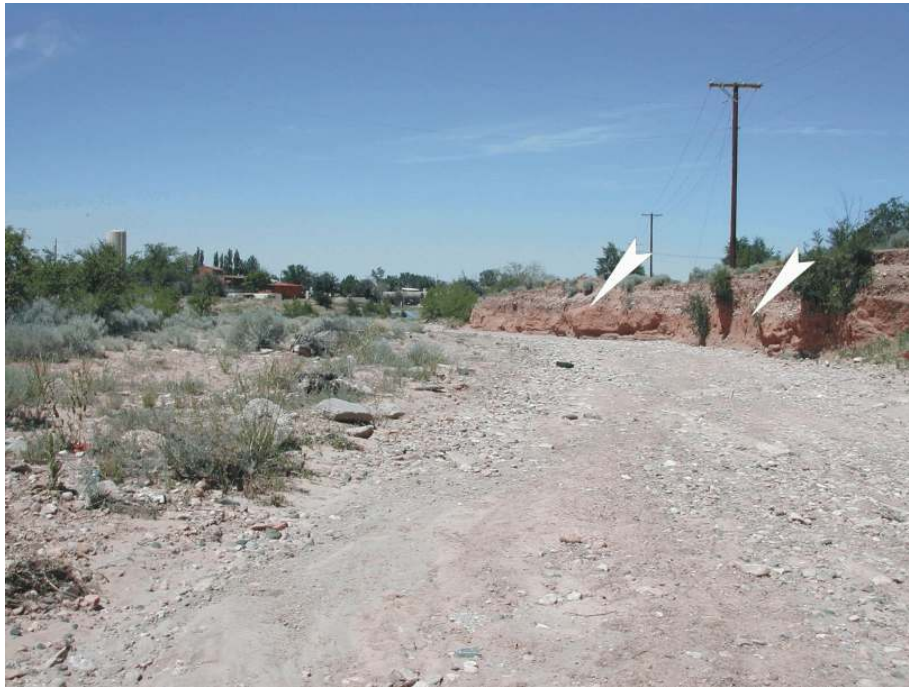
Type III (*i.e.* disequilibrium condition) C-channel reaches are characterized by rapidly eroding, often steep-walled banks. Examples of these are found in segment SFR-12 upstream from the Cottonwood Mobile Home Park and in segment SFR-7 (Figure 16).

Figure 16. Type III (disequilibrium) C5 channel. Reach is located in segment SFR-7. Arrows indicate actively eroding bank and zone of rapid channel widening. View is downstream toward the San Ysidro crossing. Photo by J. Pittenger, 26 June 2007.

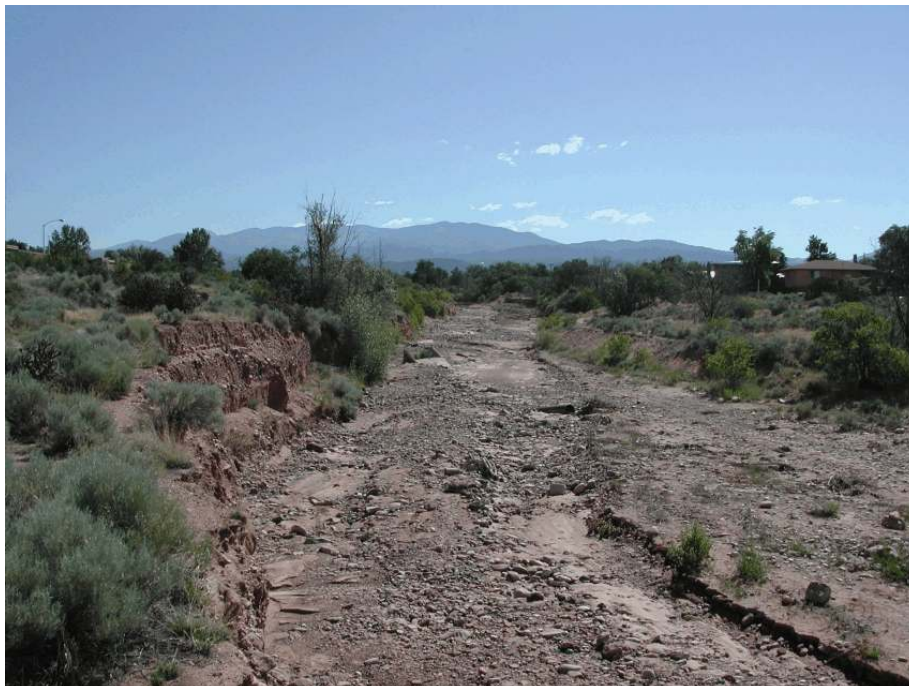
Figure 17. Stream type F4 upstream from Frenchy's Park. Coarse bed material and paucity of aggradation indicate the bed in this reach is still degrading. View is upstream. Photo by J. Pittenger, 15 June 2007.

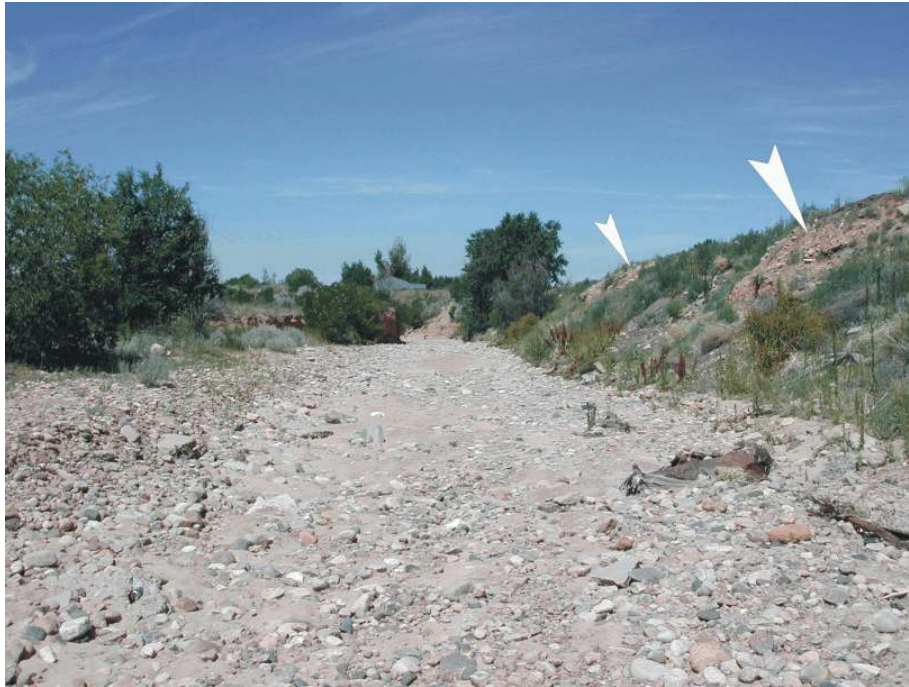
Figure 18. Channel-narrowing fill along right bank in segment SFR-4. View is downstream. Photo by J. Pittenger, 26 June 2007.

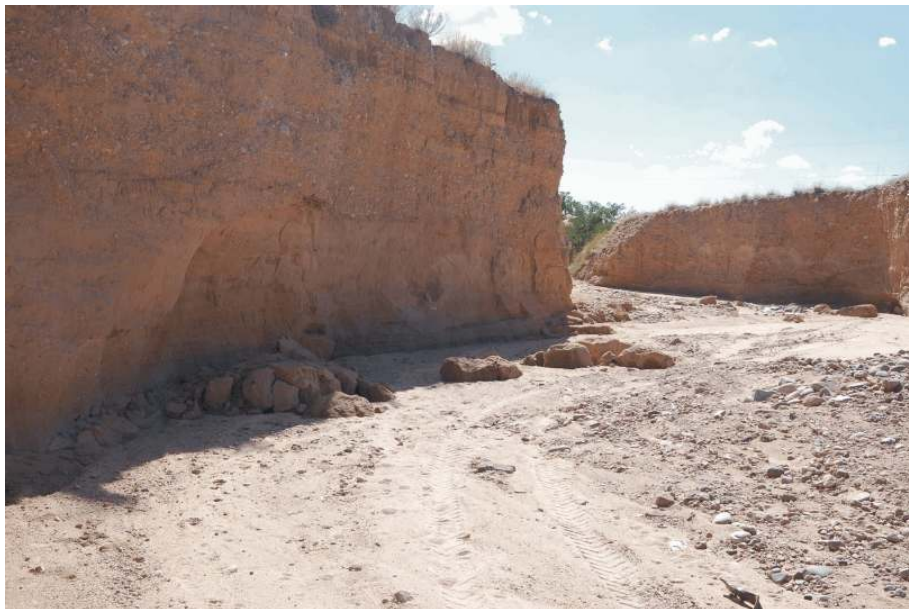
Figure 19. Deeply-entrenched F5 channel below CR 62. View is downstream. Photo by J. Pittenger, 19 September 2007.

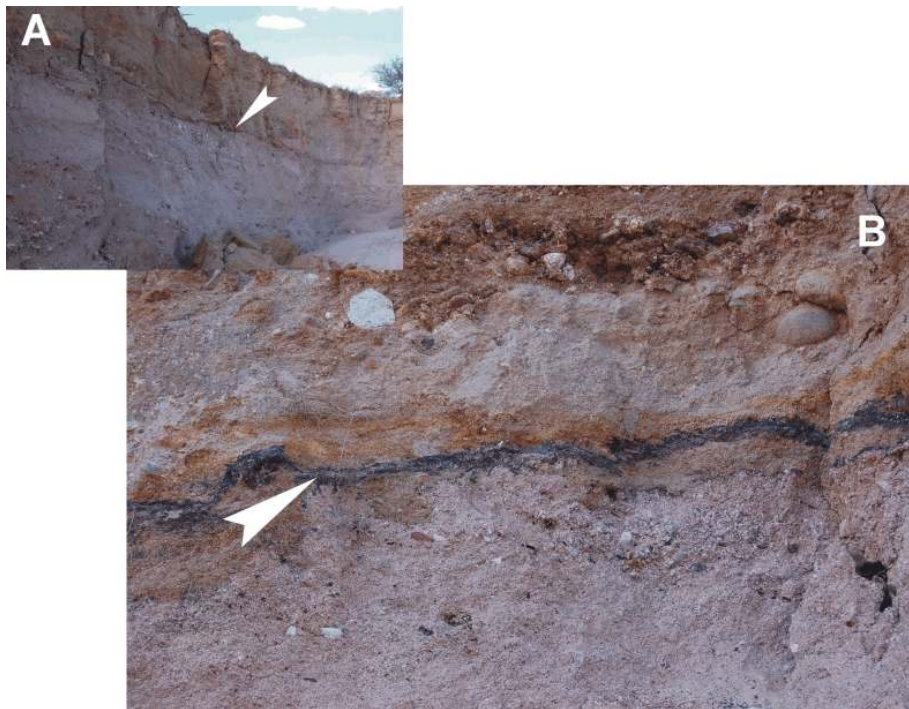
Remnant indicators of hydric soils were found in a vertical cut-bank below CR 62 at Agua Fria during field surveys in 2007. These indicators included a thin organic carbon strata overlaid by a band of iron oxide staining (Figure WET). These features were present in the cut bank about 10 feet above the current channel bed.

Figure 40. Remnant hydric soil indicators in a cut bank below CR 62 at Agua Fria. Inset photo "A" shows the location of the indicator strata about 10 feet above the current channel bed. Photo "B" shows the thin black carbon strata overlaid by iron oxide-stained sediments. Photo by J. Pittenger, 19 September 2007.

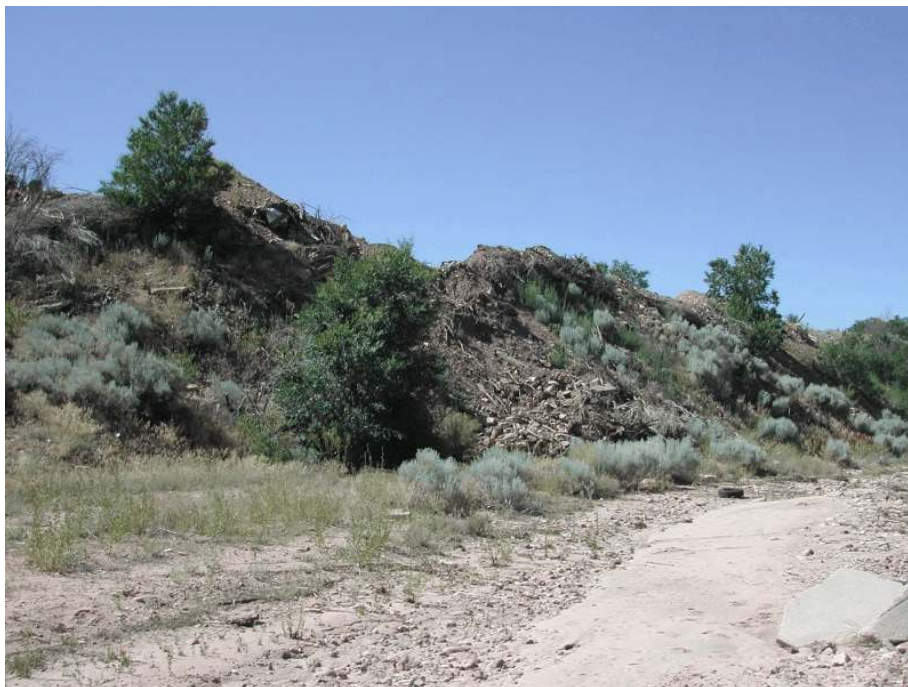
Figure 46. Waste piles spilling into the river channel. View is downstream in the reach below Camino Carlos Rael, 22 June 2007. Photo by J. Pittenger.

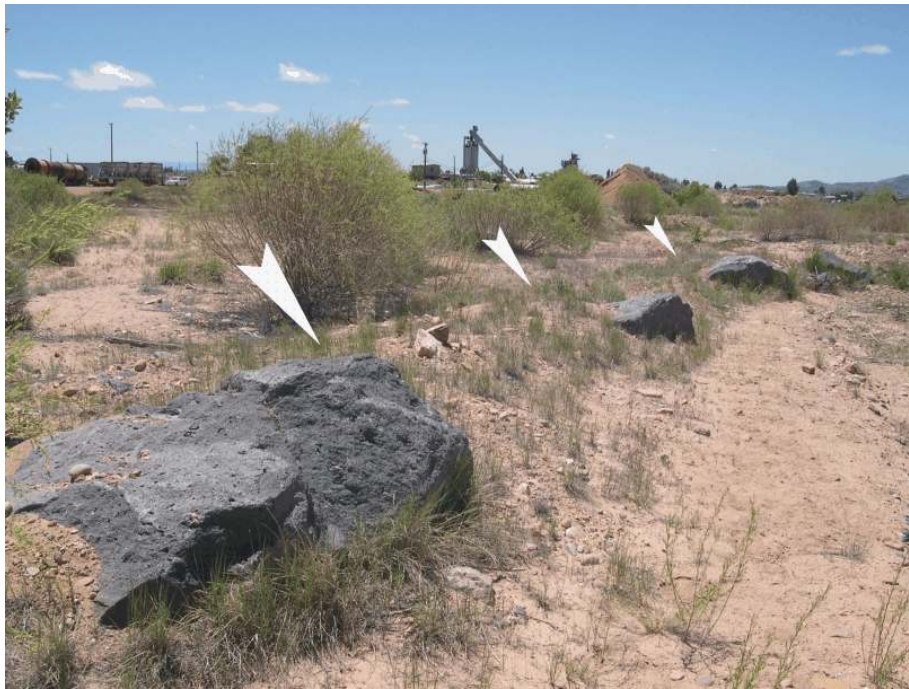
Figure 47. Unauthorized grading plugged the restored meander constructed in 2000 on State Trust land at the downstream end of the study area. Arrows indicate berm that was pushed up to block off the meander from the river. View is downstream. Current river channel bank is to the right of the berm, the restored meander channel, now cut-off from the river, is to the left of the berm. Photo by J. Pittenger, 24 May 2007.

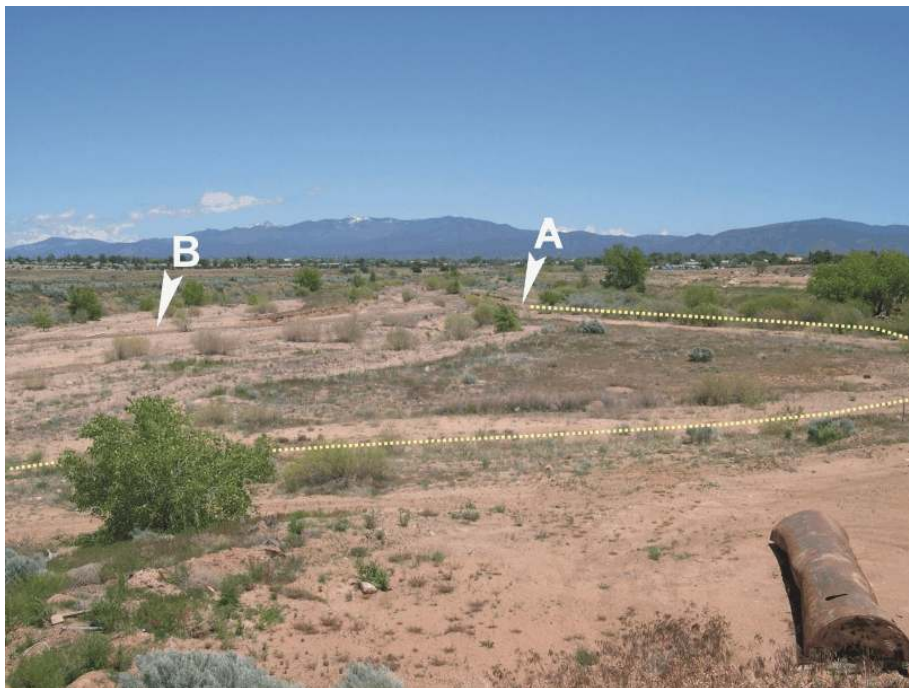
Figure 48. View upstream of the restored meander now isolated from the river. The meander channel is indicated by the dotted line. Arrow "A" shows the location of the channel plug shown in Figure 47. Arrow "B" shows the meander cut-off channel created by unauthorized heavy-equipment grading at the site. View is upstream. Photo by J. Pittenger, 24 May 2007.

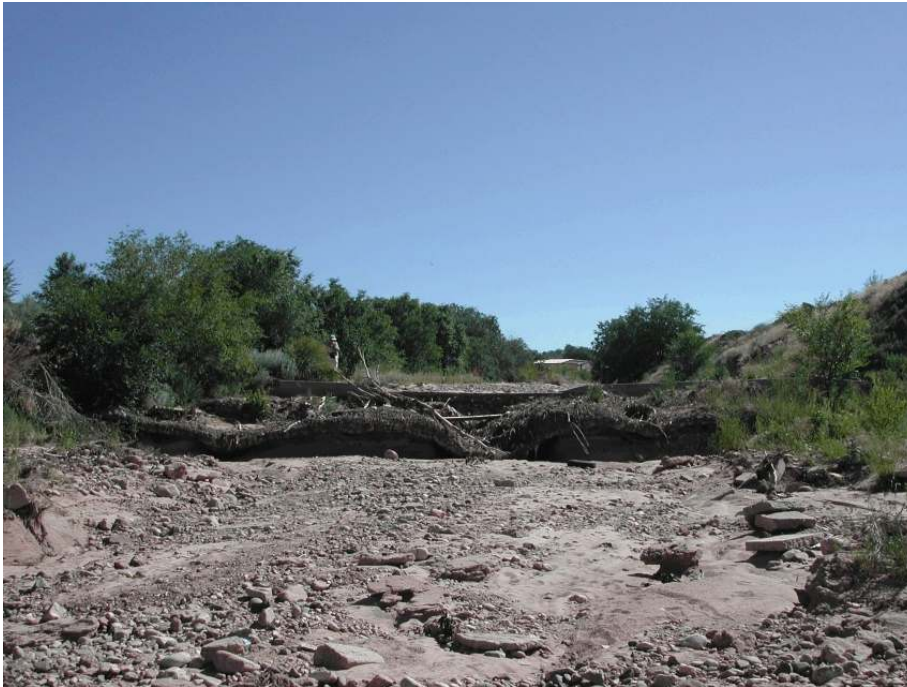
Figure 49. Grade control structure GCS-7, downstream from Camino Carlos Rael, showing failure of the erosion control apron and undermining of the structure. View is upstream. Photo by J. Pittenger, 26 June 2007.
