Santa Fe River Study

Report on Existing Environmental Conditions
and
Potential Natural Resources
Restoration Projects

5 December 2007

Prepared for
U.S. Army Corps of Engineers, Albuquerque District
Delivery Order 0014, Contract No. DACW47-03-D-005

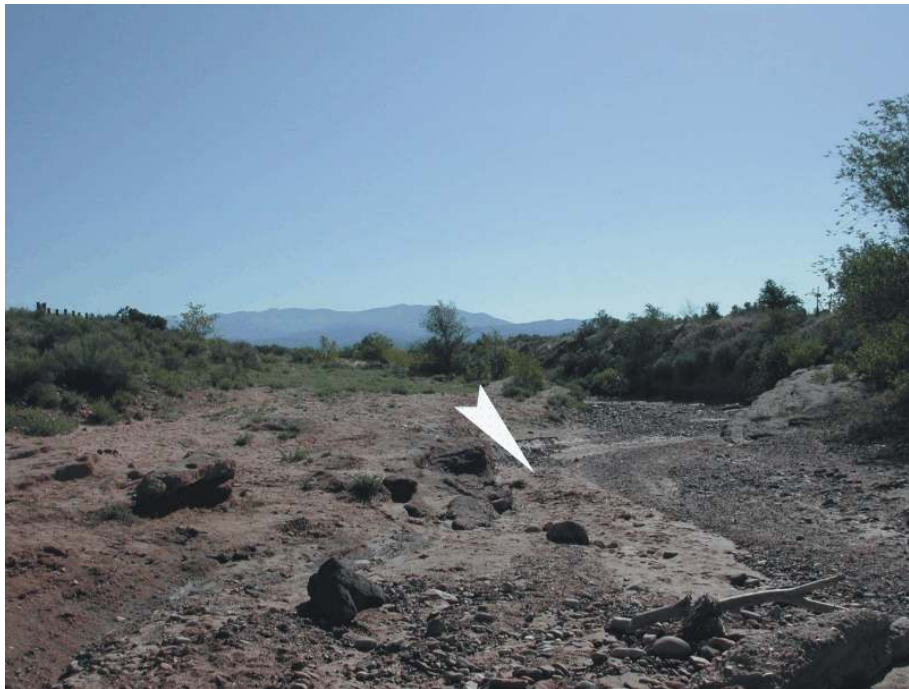
The Cieneguita Spring (Figure 8) and Agua Fria Spring sites on the Santa Fe River no longer have surface water except during periods of rainfall runoff, due to lowering of groundwater levels by groundwater withdrawal from municipal wells, reduced stream flow, and cessation of irrigation. Currently, groundwater in the Tesuque Formation is well below the surface in the study area (McAda and Wasiolek, 1988: 23) and therefore is not likely to influence existing plant growth or ecological function.

Figure 8. View upstream of the Cieneguita Spring site at present-day Frenchy's Park, 26 June 2007. Arrow indicates outcropping of compact, red conglomeratic silts of the Tesuque Formation (photo by J. Pittenger).

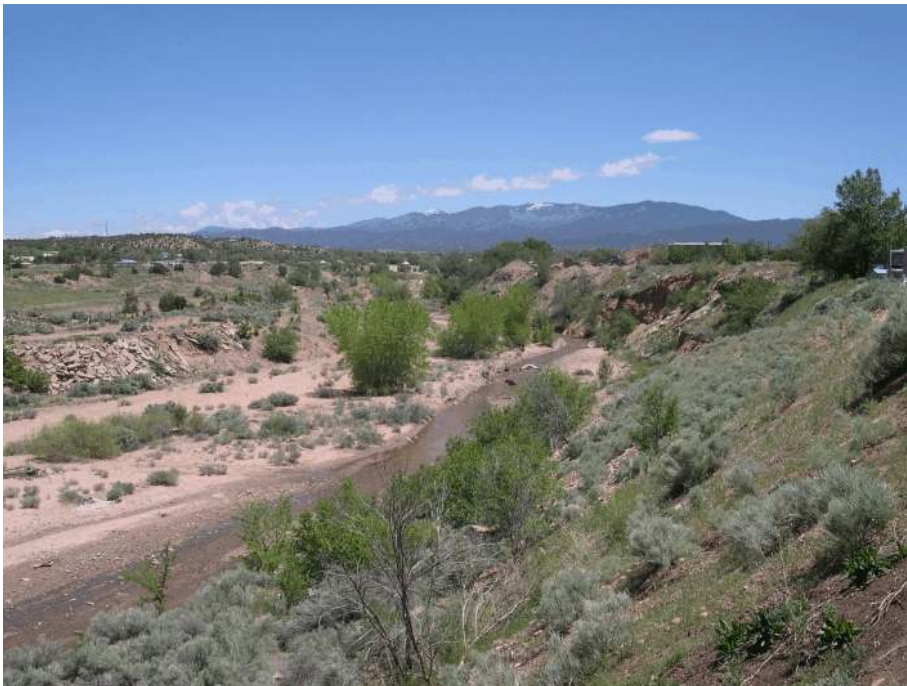
Figure 13. Stream type C4 near the Siler Road dead-end. Relatively well developed floodplain is visible in center-left. View is upstream. Photo by J. Pittenger, 24 May 2007.

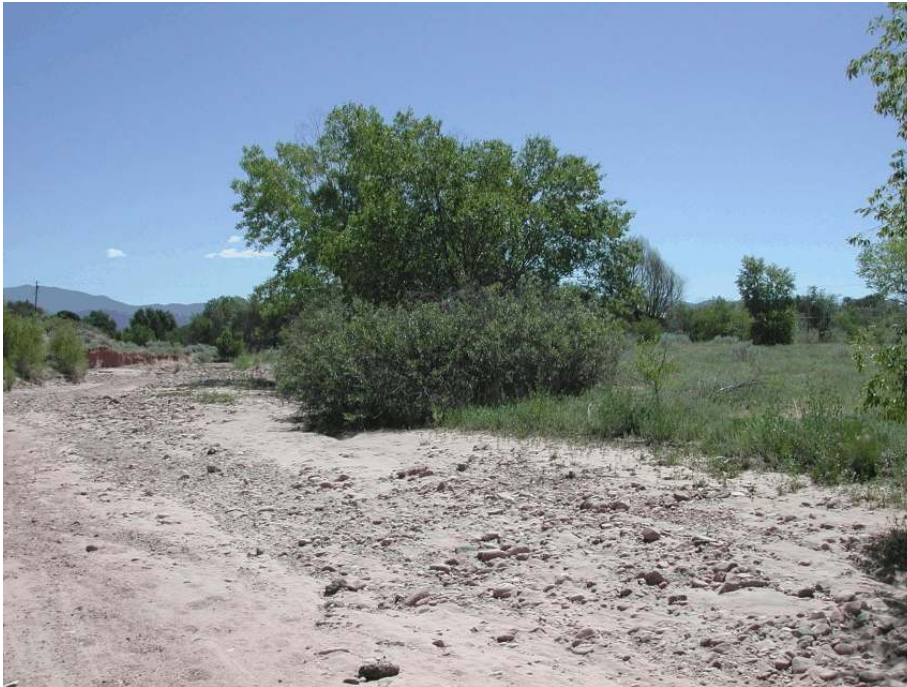
Figure 14. Stream type C4 above the Vereda de San Antonio crossing. Note the wide, accessible, undeveloped floodplain area on the right and the absence of channel entrenchment. View is downstream. Photo by J. Pittenger, 26 June 2007.

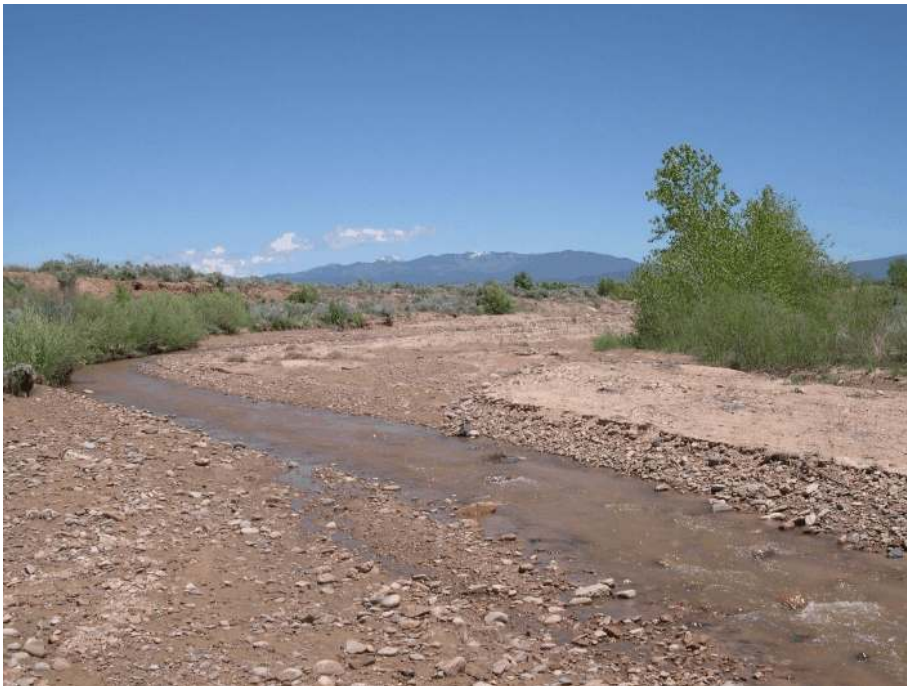
Figure 15. Stream type C5 at the lower end of the study area. A relatively well developed floodplain, moderate sinuosity, and absence of entrenchment characterize the channel in this reach. View is upstream. Photo by J. Pittenger, 24 May 2007.

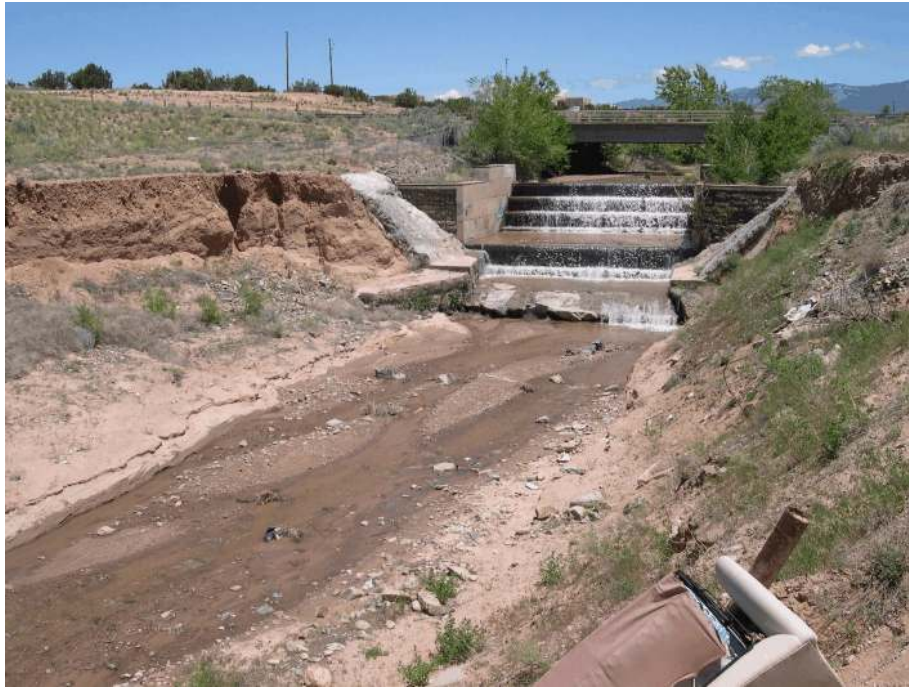
Figure 21. Grade control structure GCS-2 at the CR 62 crossing. View is upstream. Photo by J. Pittenger, 24 May 2007.

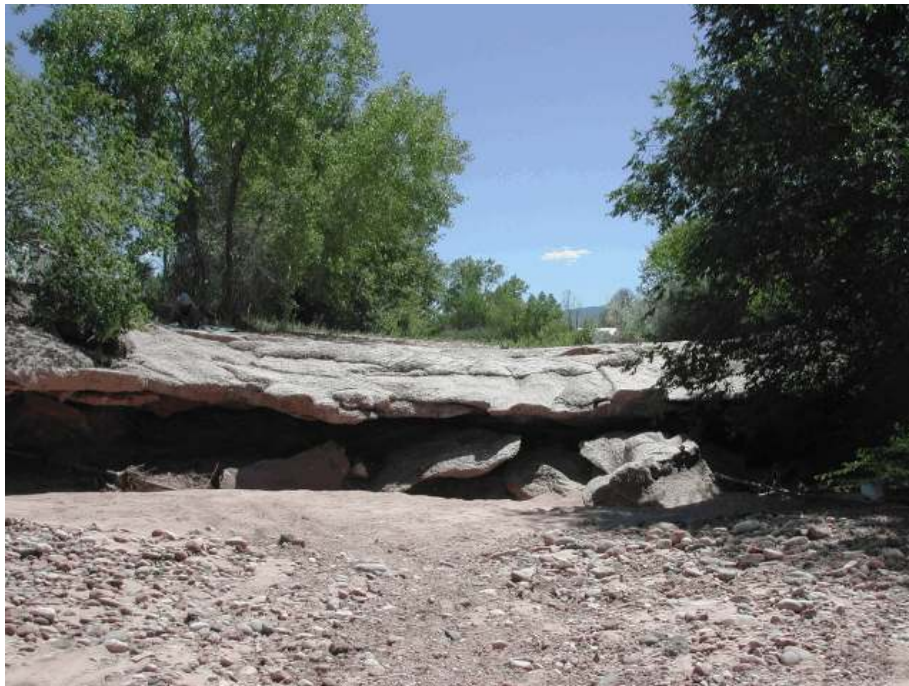
Figure 22. Grade control structure GCS-5 at the Vereda de San Antonio crossing. View is upstream. Photo by J. Pittenger, 26 June 2007.

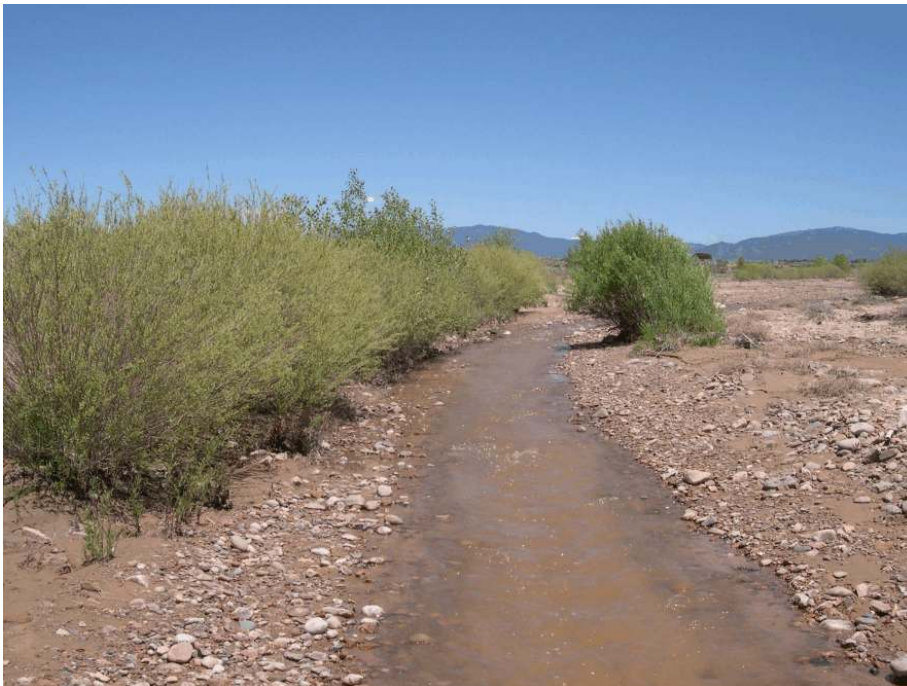
Figure 37. A C/CW VI stand on the State Trust reach above NM 599, 28 May 2007. Vegetation restored in this reach is initiating channel narrowing. Photo by J. Pittenger.

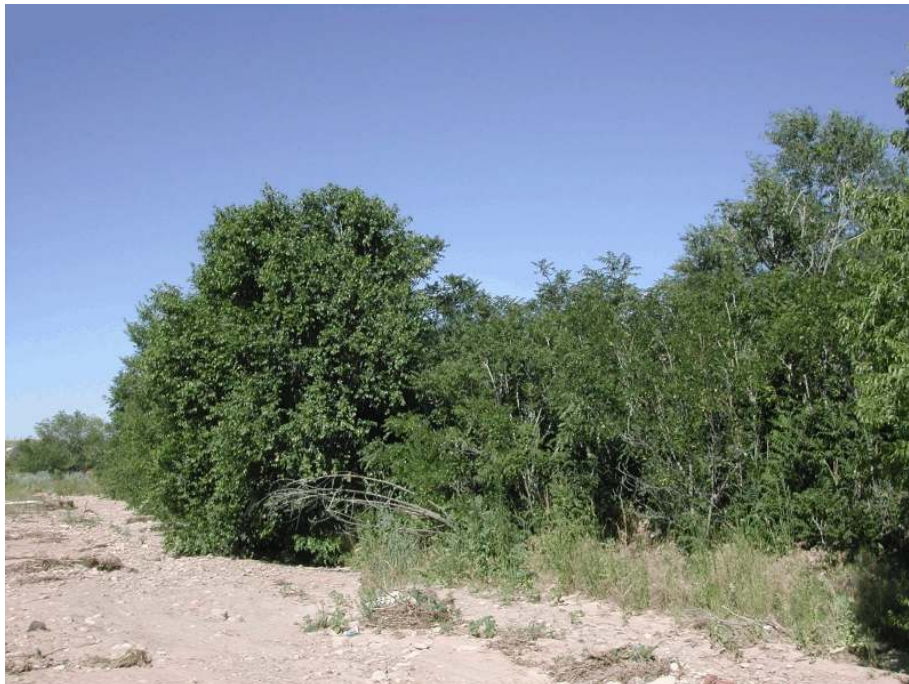
Figure 39. Stand of Siberian elm, honey-locust, and tree-of-heaven below Camino Carlos Rael, 26 June 2007. View is downstream. Photo by J. Pittenger.

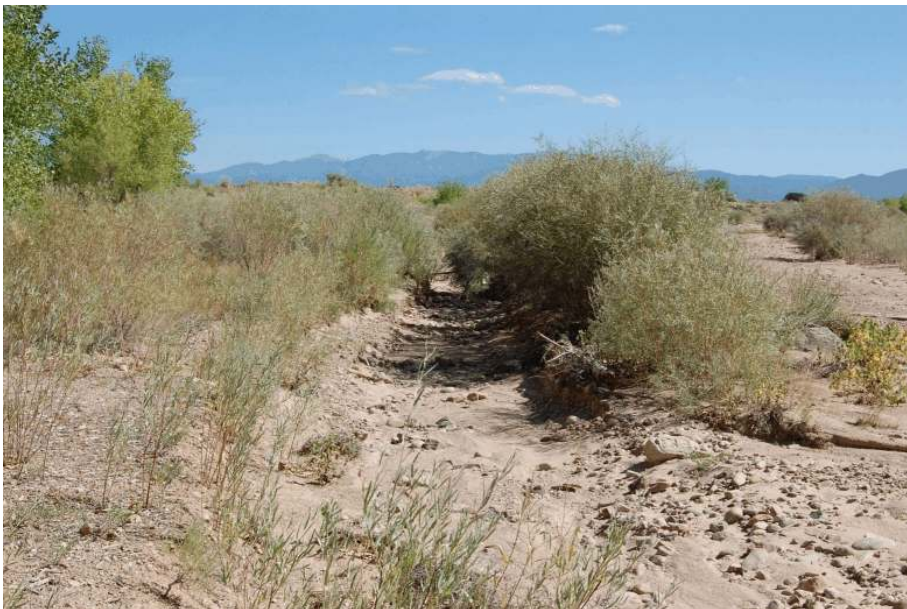
Figure 50. Coyote willow establishment on a point bar at the lower end of the study area. View is upstream in a secondary channel on a point bar that was restored in 2000. Photo by J. Pittenger, 20 September 2007.

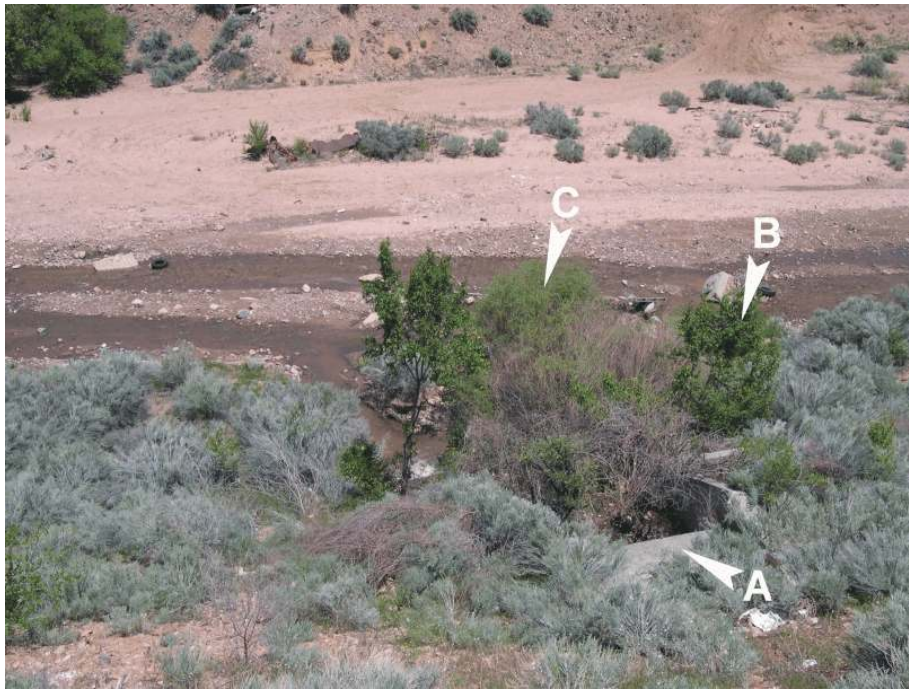
Figure 51. Storm drain outfall SW-12 at Siler Road. The culvert outfall (A) is shaded by vegetation. Cottonwood saplings (B) and coyote willow (C) are growing amongst Siberian elm and rabbitbrush at the site. Photo by K. Yori, 12 July 2007.

Retention basins would serve as excellent sites for establishing stands of coyote willow and cottonwood or improving existing stands by retaining run-off and allowing it to percolate into the alluvium (Figures 51 and 52). Development of wetlands dominated by herbaceous plants (*e.g.* sedges, bulrushes, rushes, obligate and facultative wetland forbs) may also be possible if retention basins are not subject to excessive sediment deposition or scour.

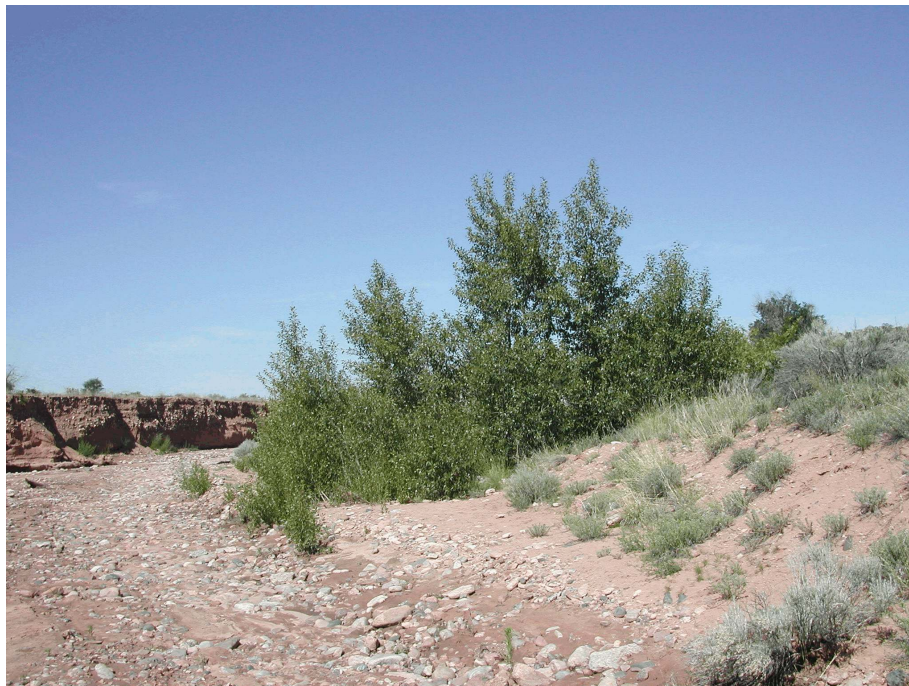
Figure 52. Stand of narrowleaf cottonwood at structure SW-5. View is downstream. Photo by J. Pittenger, 15 June 2007.

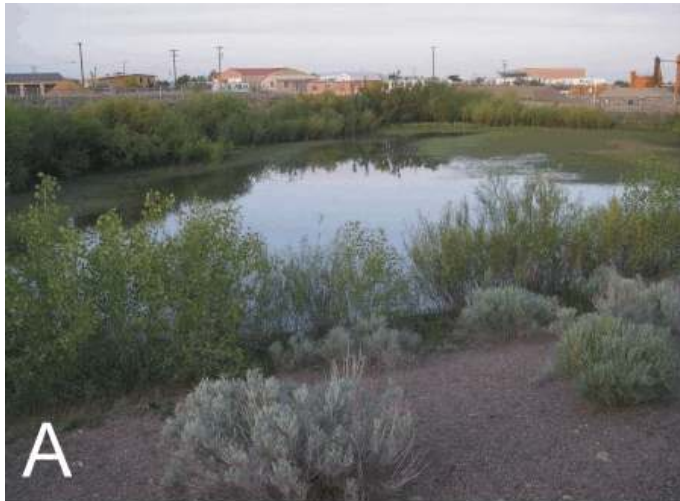
Figure 54. Storm-water detention pond near the NM 599 bridge. The pond held water (photo A, 24 May 2007) for a considerable period in spring 2007. After water levels receded, the bottom of the pond was colonized by annual plants (B, 19 September 2007). Woody vegetation on the pond banks includes coyote willow and Rio Grande cottonwood. Photos by J. Pittenger.

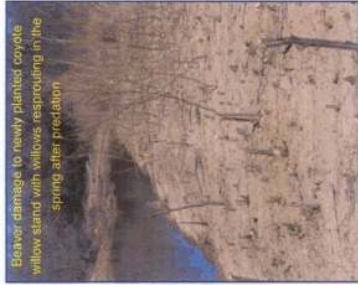
Beaver damage to newly planted coyote willow stand with willows resprouting in the spring after predation.

- Beaver damage—Willow whip cuttings can be damaged by beaver predation. Even though the entire aboveground portion of a newly planted whip might be consumed, the below-ground stem often has sufficient reserves to sprout and form new shoots.
